Manhole Inspection Summary

Manhole # S47C__032MH

Record Plat: **47C** Node: **032** Status: **Found**

Insp Date: **7/14/08 2:07 PM**

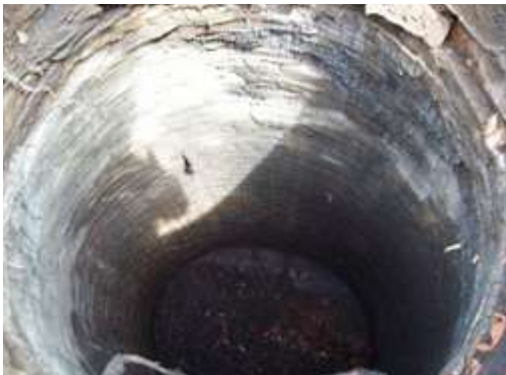
Defect 2

frame leaks

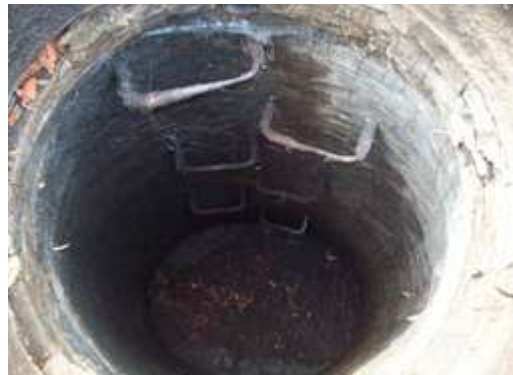
Defect 1

Infiltration: ☐ None ☐ Joint ☐ Cracks ☒ **Mortar** ☐ Roots ☐ Wall

Infiltration: ☐ None ☐ Joint ☐ Cracks ☐ Mortar ☐ Roots ☒ **Wall**

infiltration

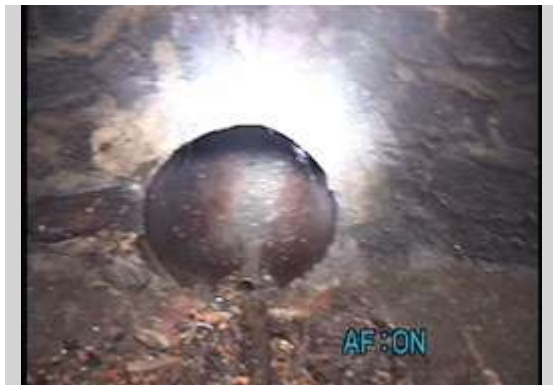
12 O'Clock Outflow

8 in. Circular Gravity Sewer
Pipe Out @ 12 O'Clock

Infiltration: **None** Pipe Seal Cond: **Sound**
